UNAPPROVED PARTS NOTIFICATION

No. 99-228 August 29, 2000

Aircraft Altimeters.

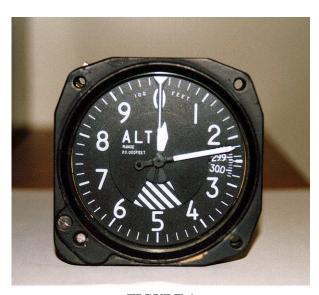
FIGURE 1

DATA TAG ON THE INSTRUMENT CONTAINS THESE MARKINGS

INSTRUMENTS & FLIGHT RESEARCH, INC. 2716 GEORGE WASHINGTON BLVD. WICHITA, KS 67210

Mfg. P/N: IFR 46-20 S/N XXXXX

Regulations require that type-certificated products conform to their type design. Aircraft owners, operators, maintenance organizations, parts suppliers and distributors should inspect their aircraft, aircraft records, and/or parts inventories for any altimeter distributed by Instrument and Flight Research, Inc. If any referenced altimeter is installed on an aircraft, appropriate action should be taken. If any of the altimeters are found in existing parts inventory, it is recommended that the altimeters be quarantined to prevent installation until a determination can be made regarding each altimeter's eligibility for installation.
